MEMORANDUM

Date: January 25, 2014
To: *Bear Creek Watershed Association*
From: Russell N. Clayshulte, Manager
Re: **Technical Report 2013.03 – 2013 Coyote Gulch Data Summary/ Record and Association Trade Credit**

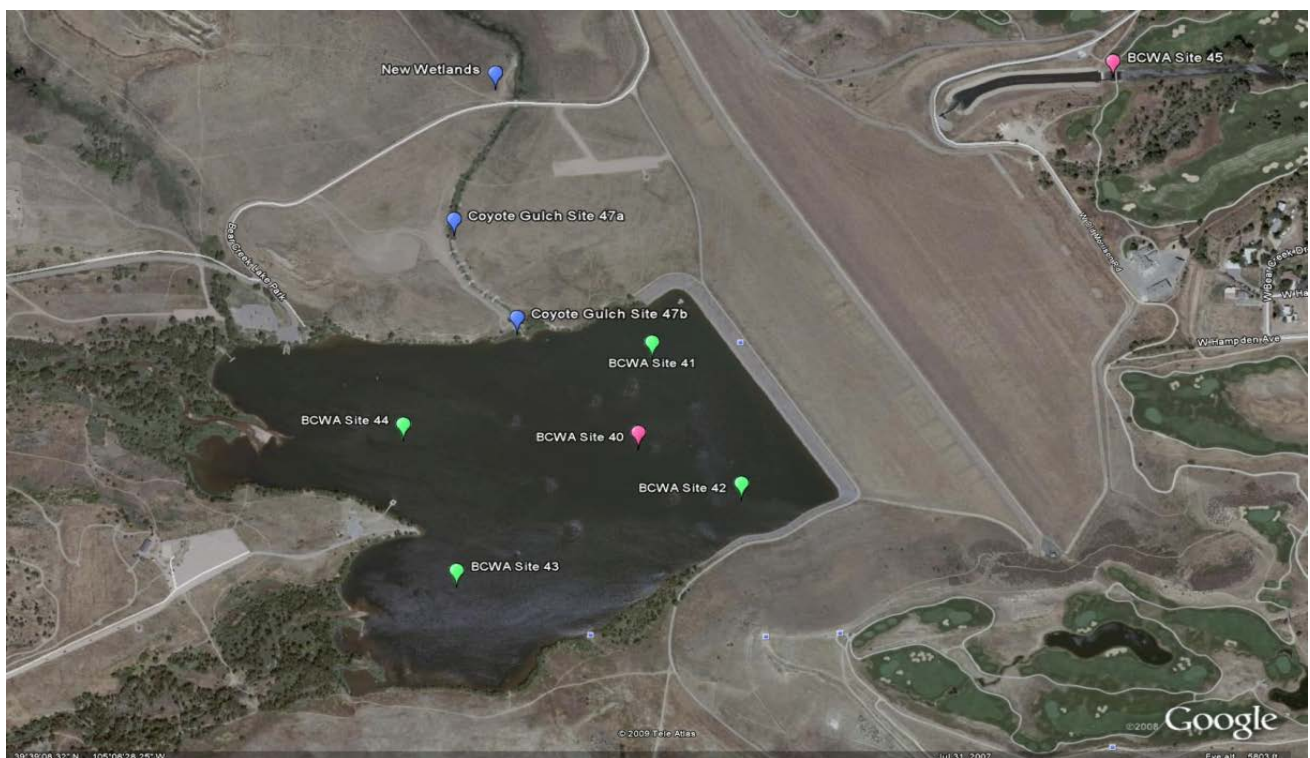
Figure 1 Coyote Gulch Discharges into Bear Creek Reservoir

The Association coordinates with the City of Lakewood a sampling program on Coyote Gulch in the Bear Creek Park (Figure 1). The monitoring is done at two sampling sites: above the restoration project (Upper Coyote), and at the discharge into the reservoir (Lower Coyote) (Figure 2). Beginning in 2013, the Association incorporated the nutrient sampling into the Association monitoring program as part of the P2 Supplemental Monitoring Program. The Association reduced the monitoring frequency to bi-monthly. Nutrient analyses are done at the Association's contract laboratory GEI Consultants Inc. The Association collects the chemistry data for total phosphorus, total nitrogen, ammonia-nitrogen and nitrate-nitrogen (Table 1). The Association takes bi-monthly flow measurements to determine nutrient loading. The Association also collects data for temperature, pH, specific conductance and Dissolved Oxygen. Data results are incorporated into the Association monthly and annual data summaries (Tables 2, 3, and 4). The Association has pre-construction and post-construction loading data. This monitoring project has established a total phosphorus trade credit for use of the Association membership.

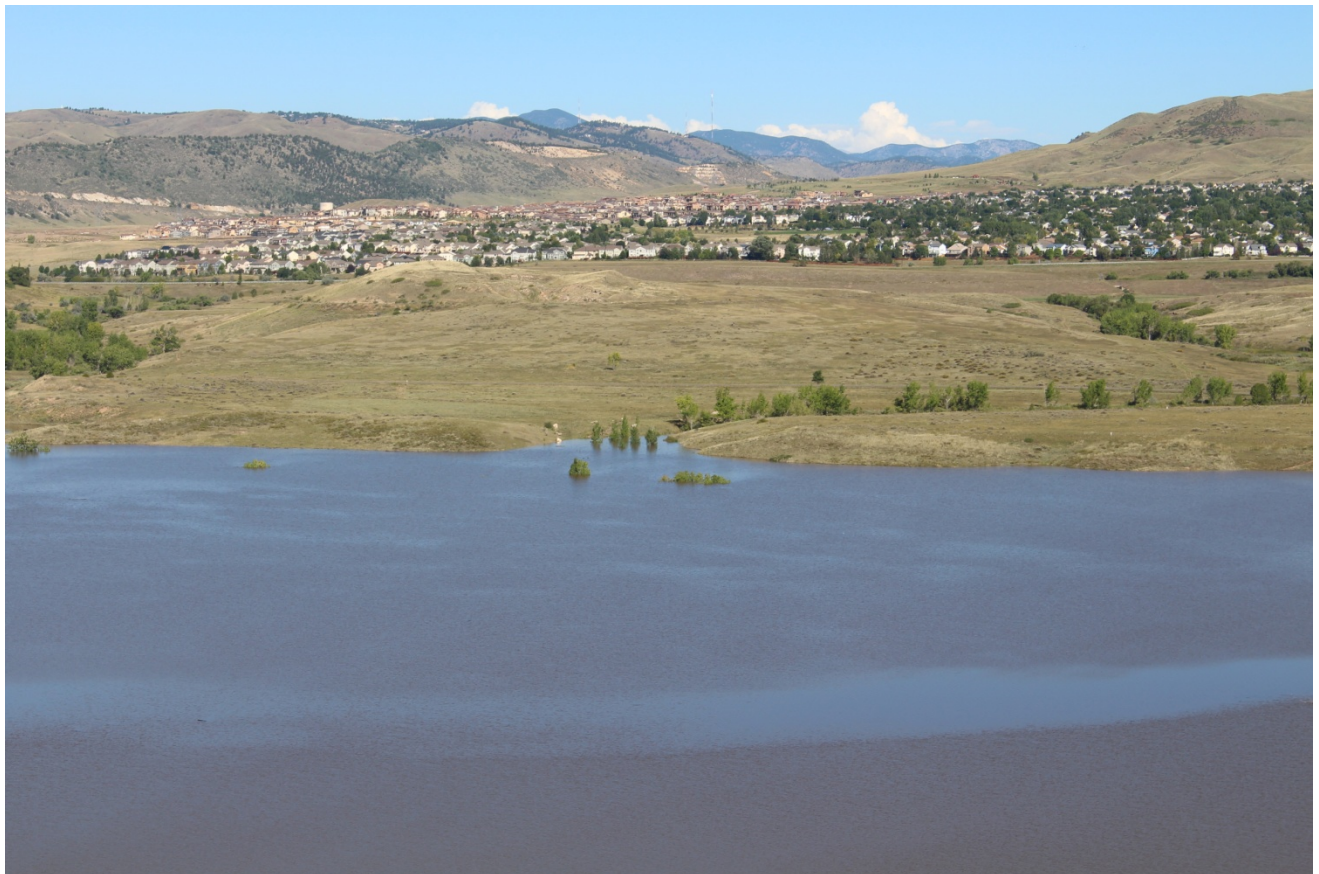
Figure 3 Flooded Coyote Gulch

In September 2013, the reservoir became a major flood control structure. The rains began in earnest on September 9, 2013 in the upper watershed. The U.S. Army Corps of Engineers shut the outflow gates on Bear Creek Reservoir on September 13, 2013. The pool rose from 1,817 acre-feet to about 15,000 acre-feet (5 trillion gallons) on September 22, 2013. The surface area was about 500 acres or 70% of surface acre capacity. Although Bear Creek Reservoir returned to normal pool by the end of October, the water quality in the reservoir may be altered for years to come. The entire Coyote Gulch project site was submerged. The site was underwater for about 30-days. Figure 3 shows the Coyote Gulch drainage with the water level just about the Upper Coyote sampling point. The project site was cover by fine muds from 1-4 mm thick (Figure 4). Analyses of these muds show a considerable amount of nutrients. This flooding event may affect the project. There was some vegetation dye-off due to the submergence.

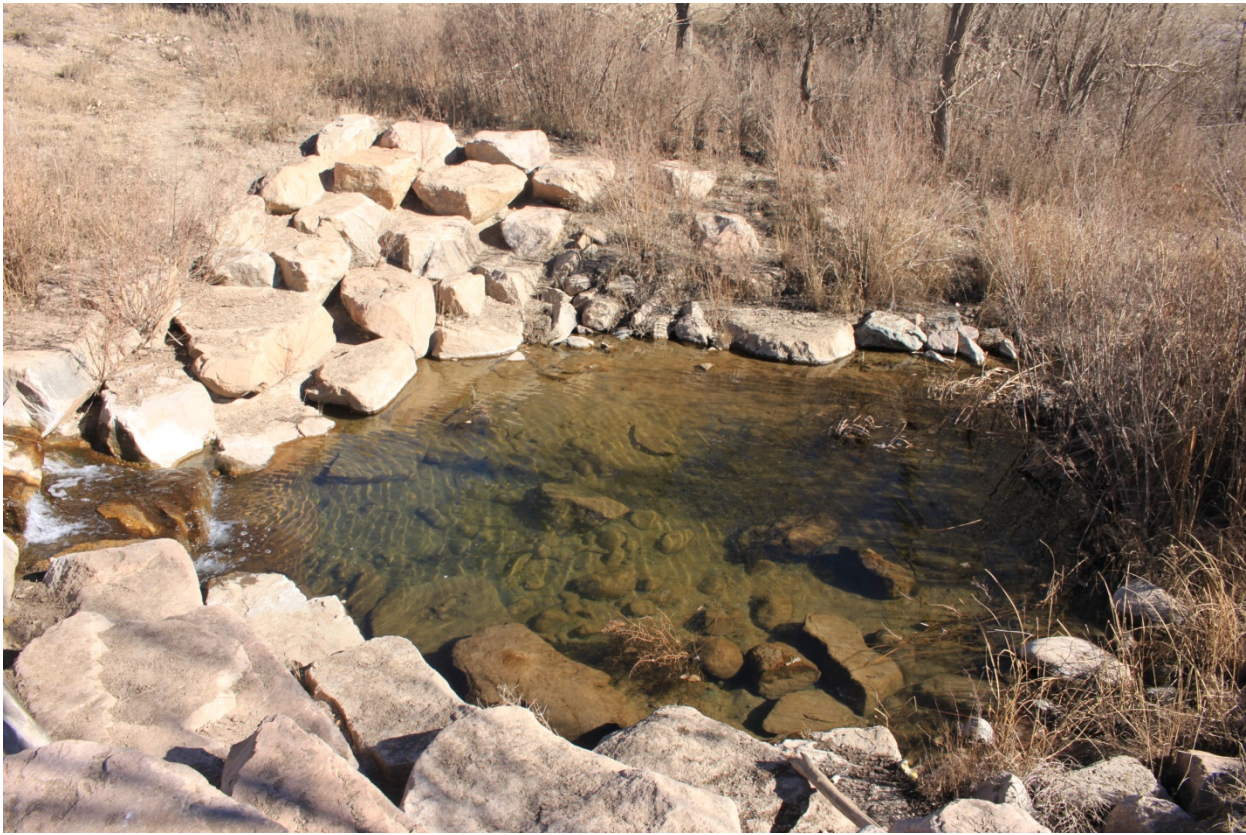
Figure 4 Fine muds coat surfaces in Coyote Gulch

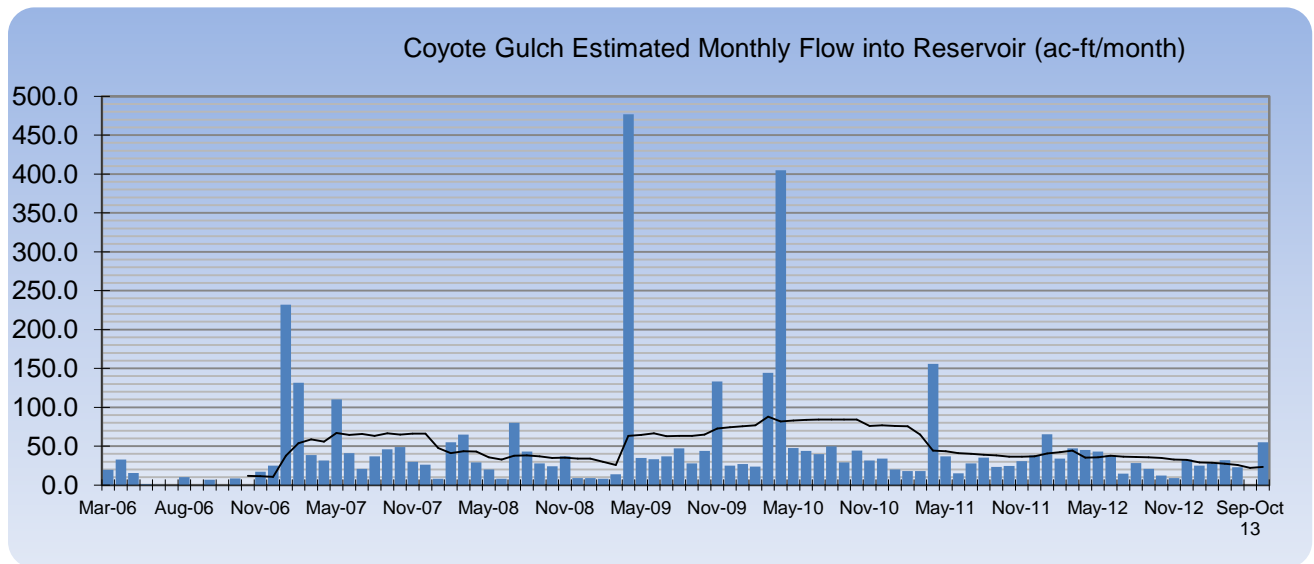
Figure 5 Coyote Gulch Estimated Monthly Flow Summary

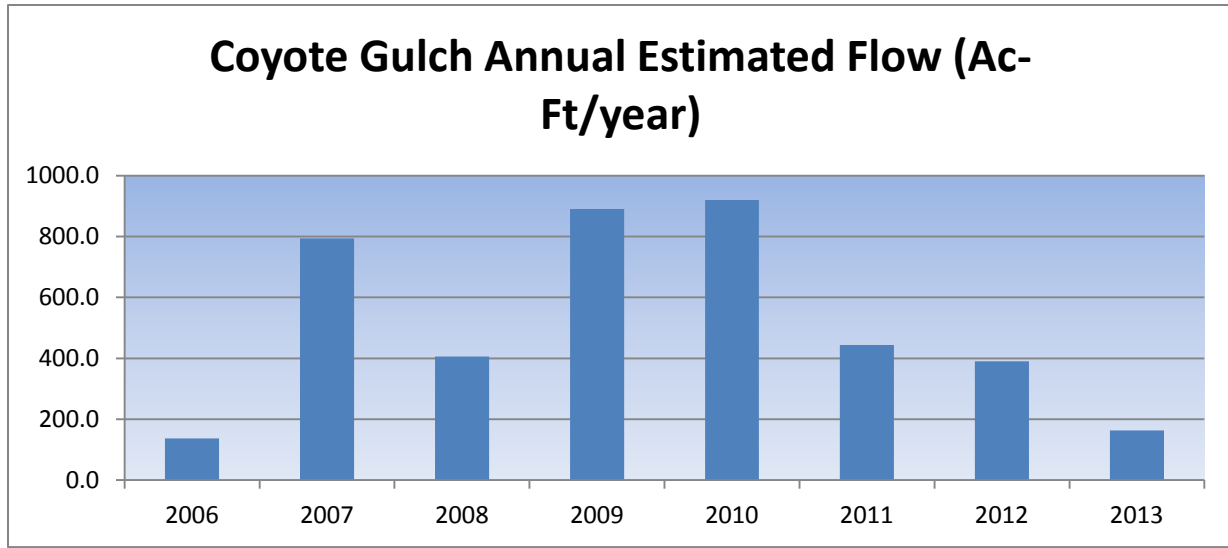
Figure 6 Annual Estimated Flows from Coyote Gulch into Bear Creek Reservoir

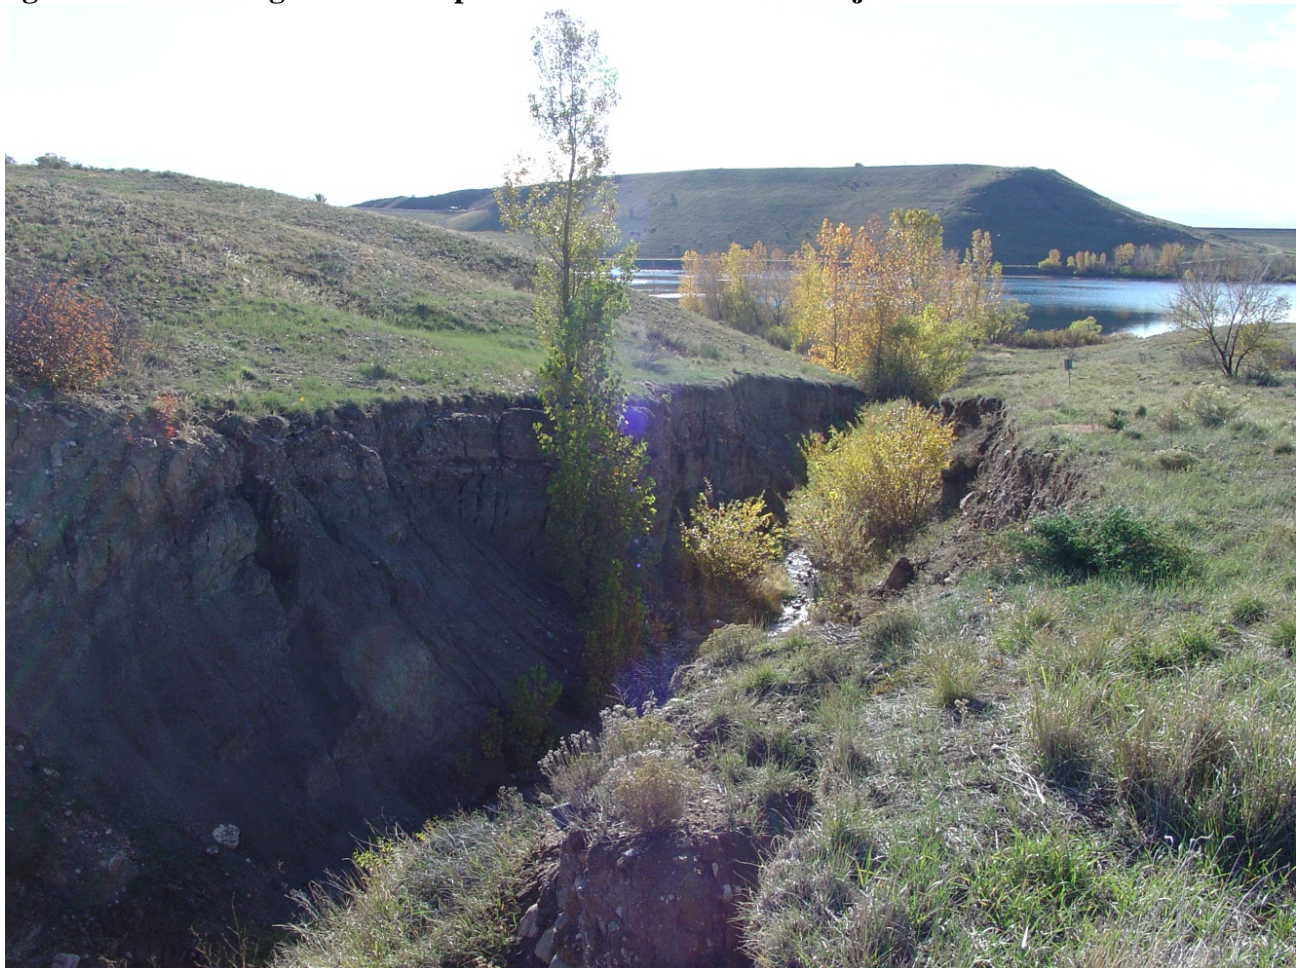
Figure 11 Coyote Gulch Pre-Construction

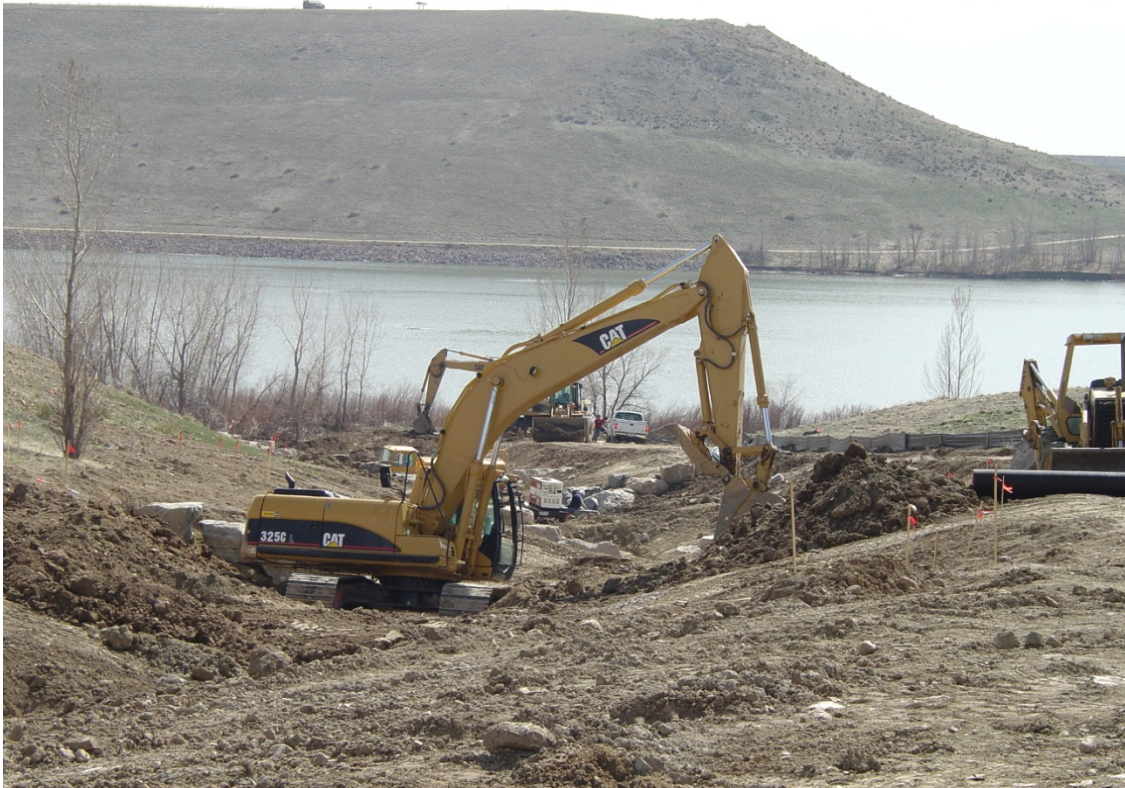
Figure 12 Coyote Gulch During Construction

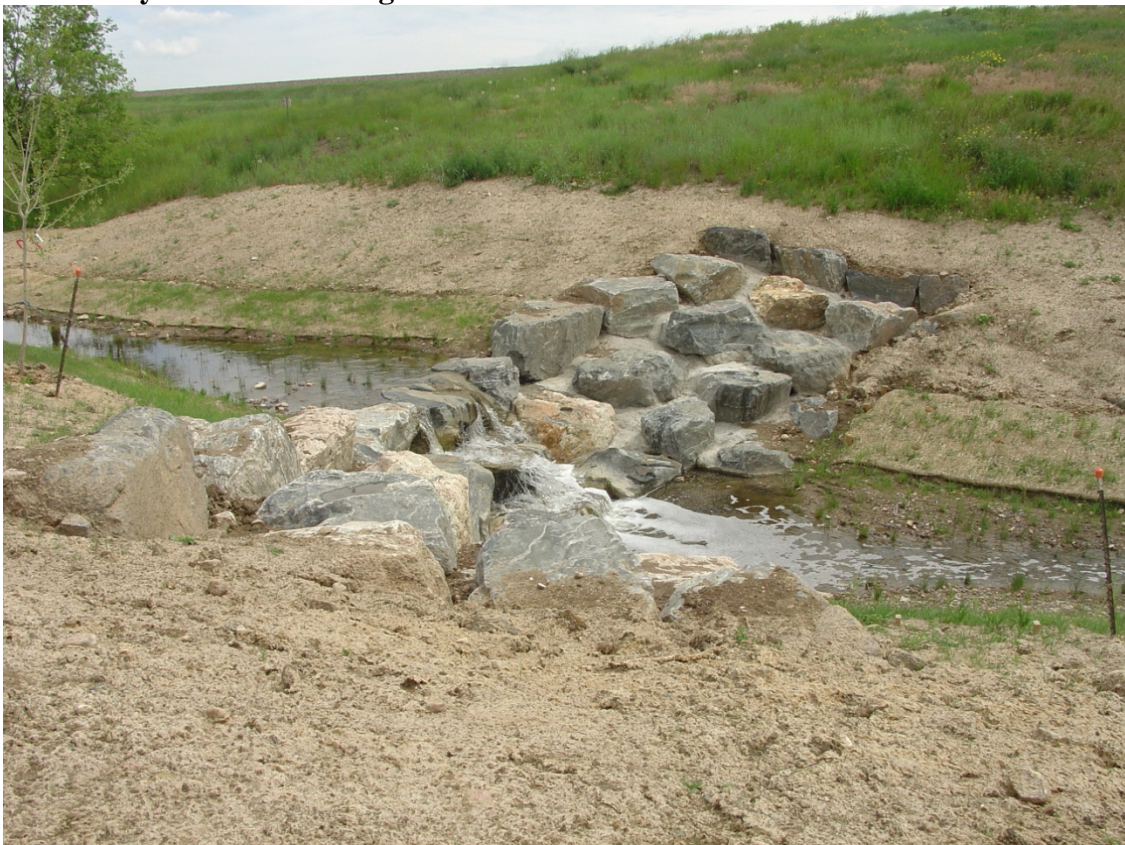
Figure 13 New Stone Check Dam Installed

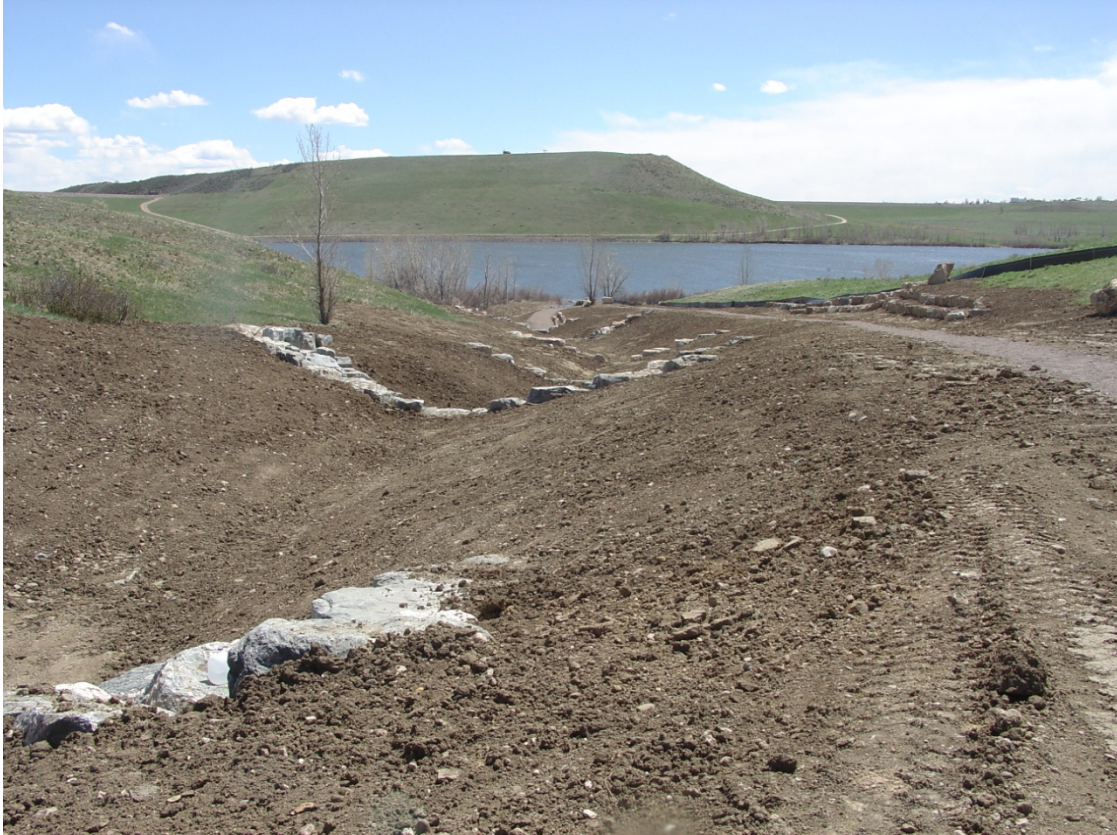
Figure 14 Coyote Gulch Construction Completion without vegetation

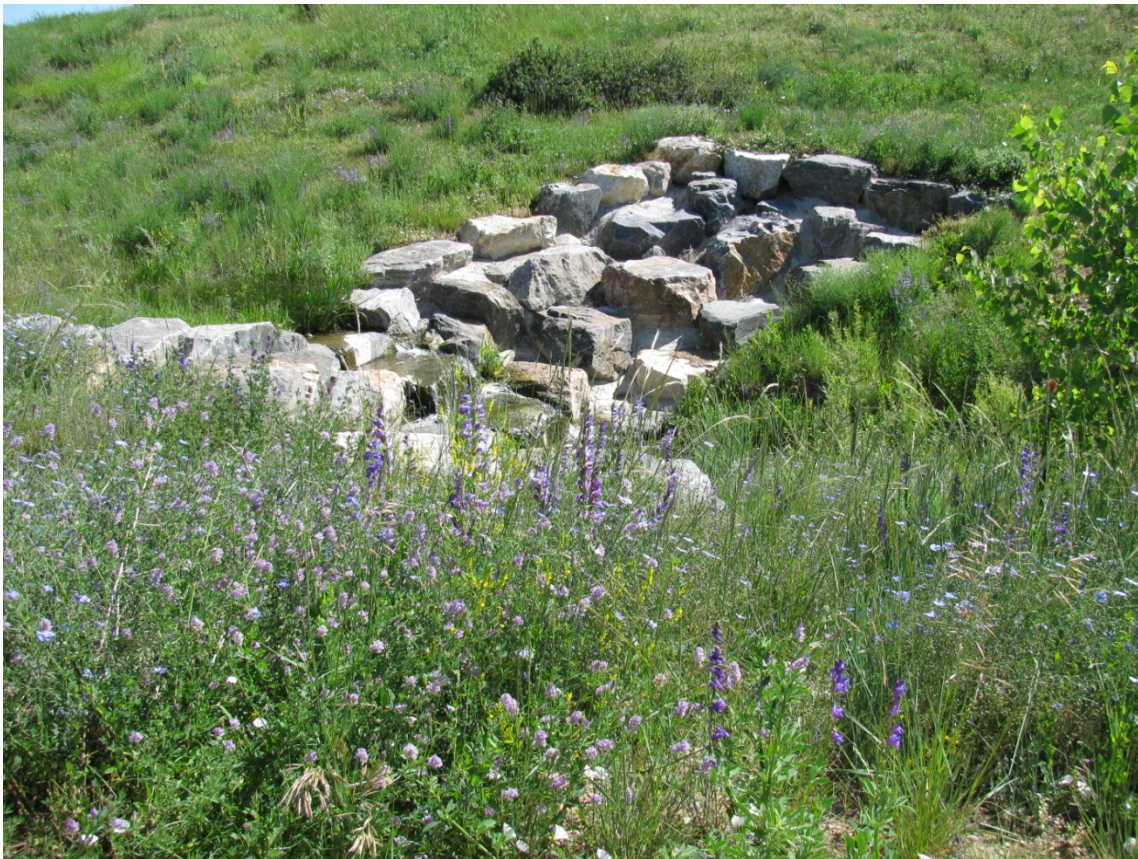
Figure 15 Check Dam from Figure 15 with Vegetation

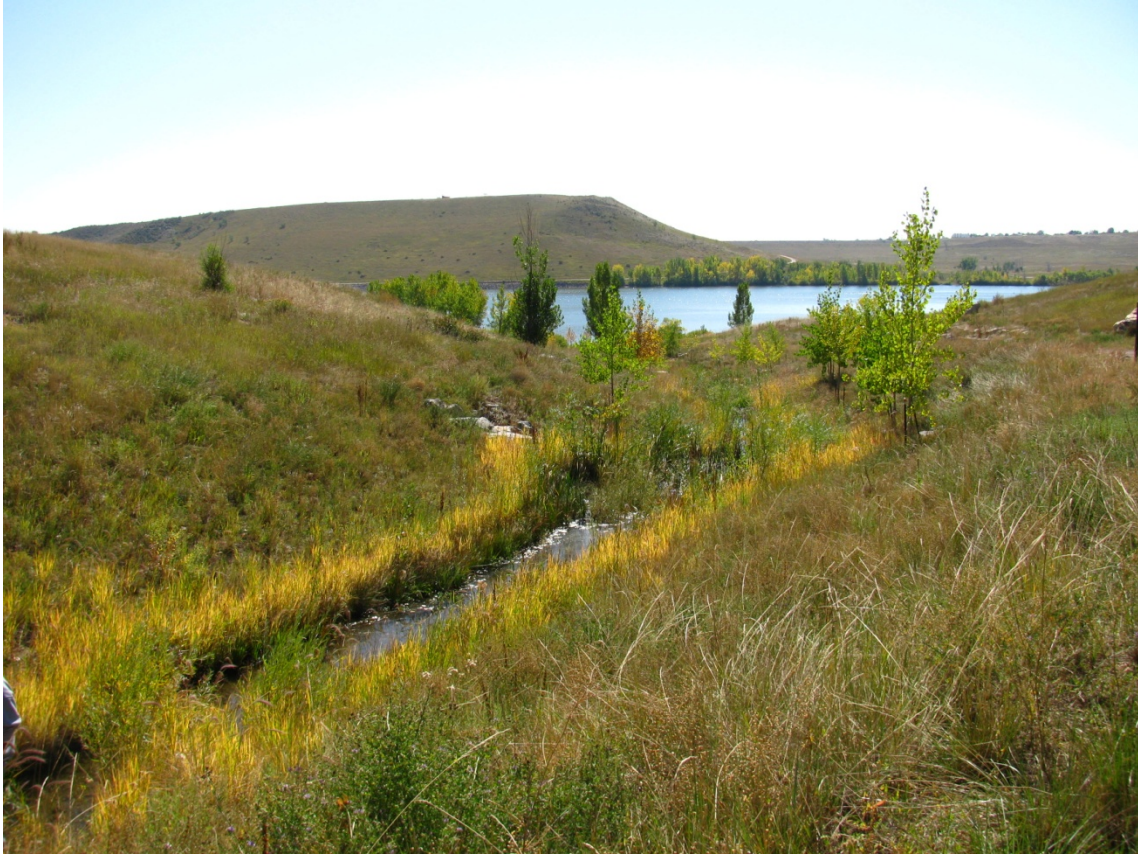
Figure 16 Coyote Gulch as Stabilized in Fall 2009

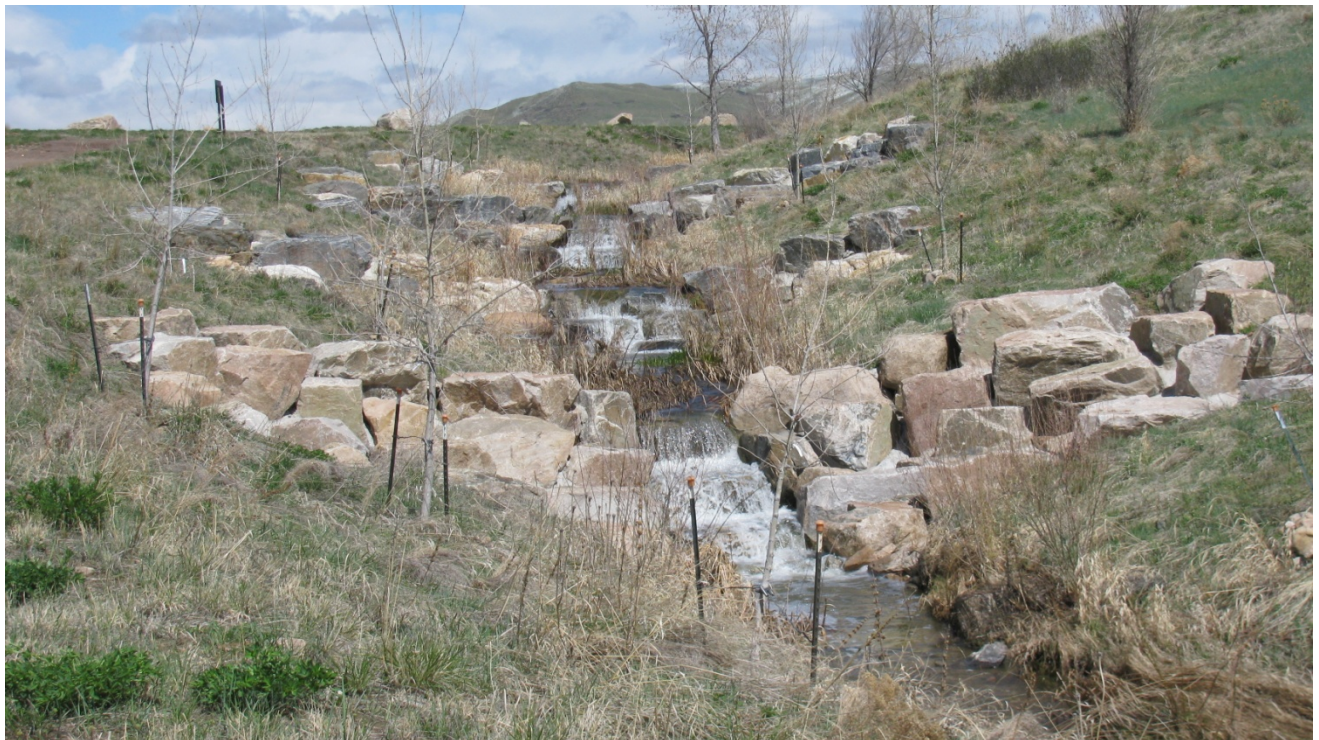
Figure 17 Lower Coyote April 2010 with Storm Flows

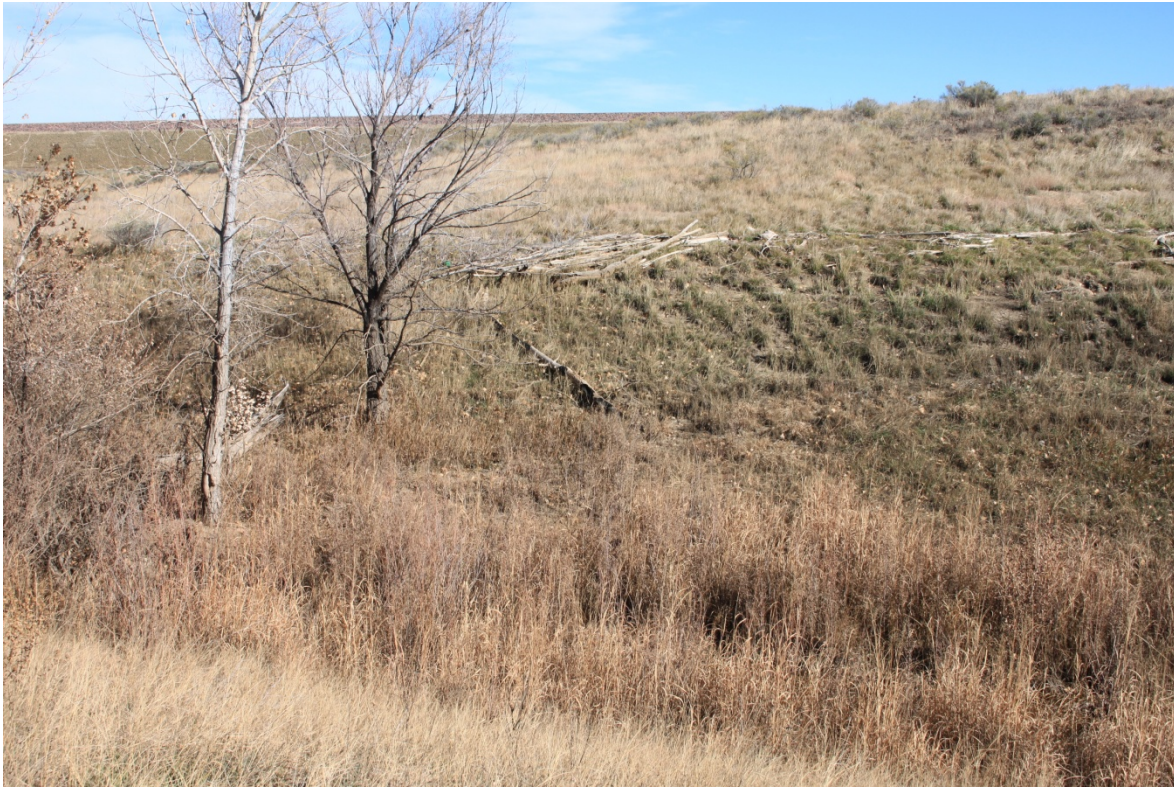
Figure 18 **October 2013 after submergence at Upper Coyote (See debris line)**

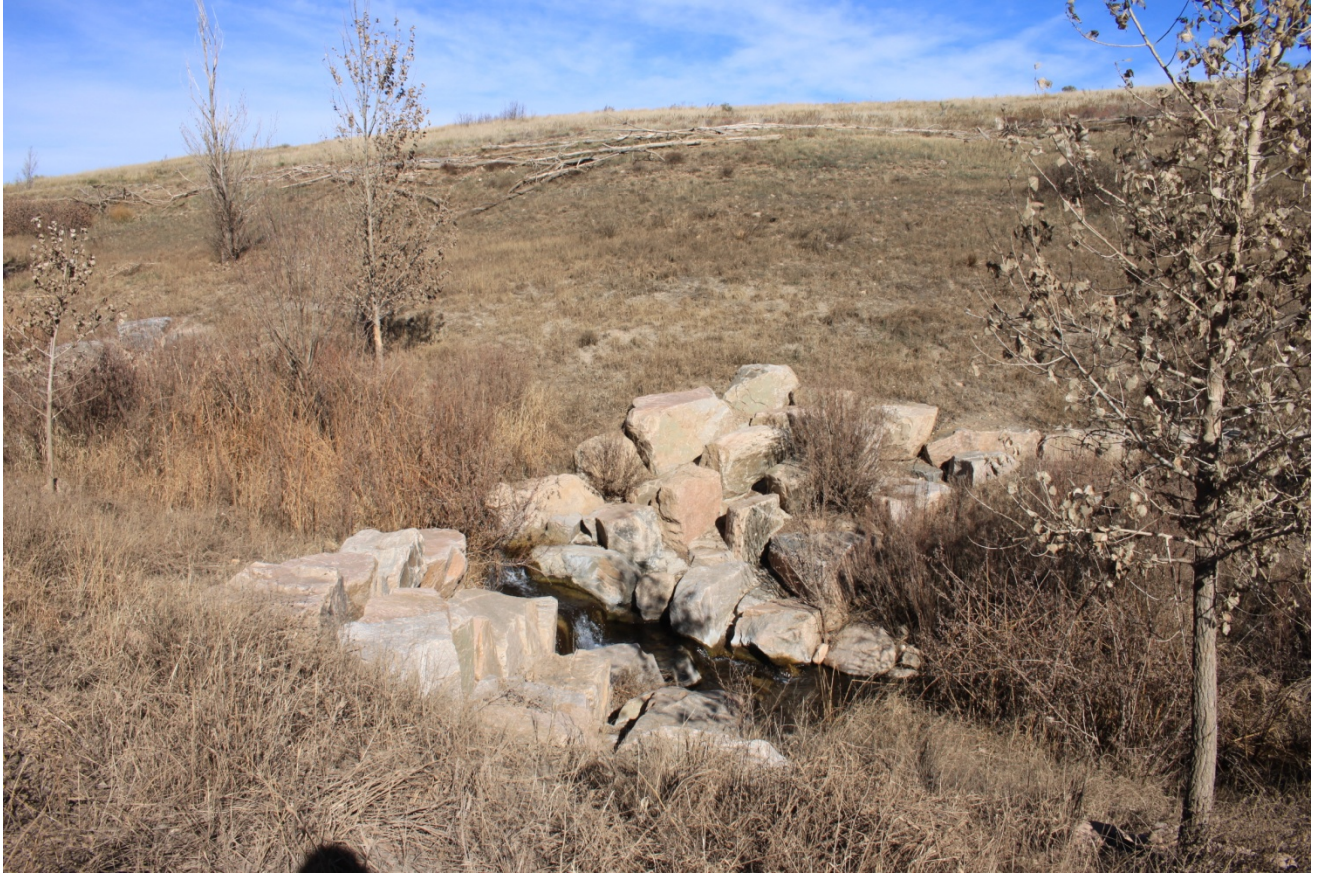
Figure 20 Rock drop structures not affected by submergence (November 2013)
