Bear Creek Watershed Association

2009 Annual Report for the Water Quality Control Commission

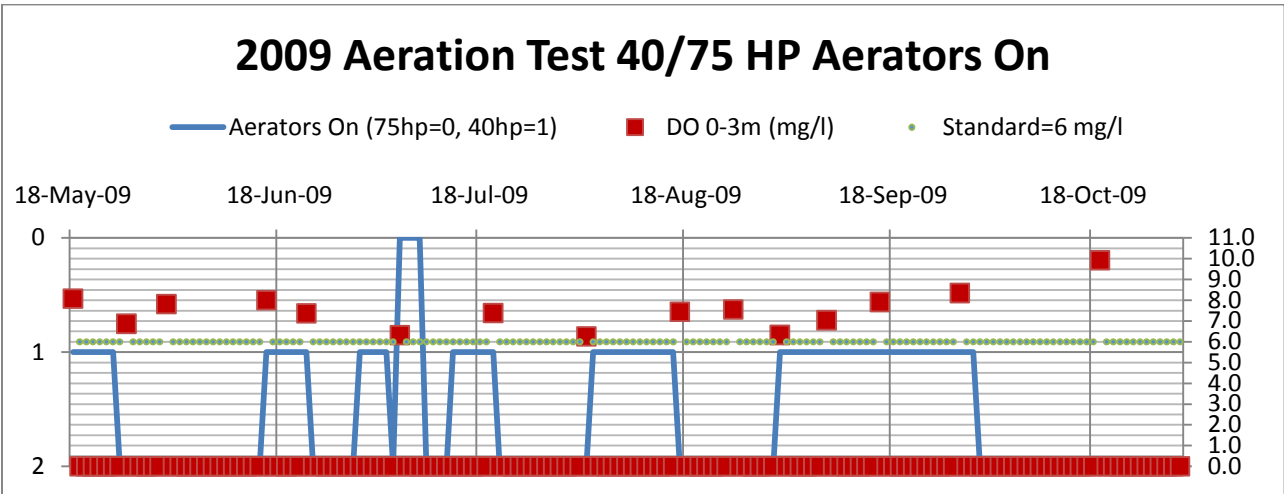
Figure 21 Reservoir Aeration Operational Testing

The current aeration system has been operational since the summer of 2002 and uses a fine-bubble diffusion system with aerators distributed across the hypolimnion. In 2009, the Association and Lakewood ran operational studies to determine the effectiveness of the aeration system in oxygen transfer during phased on-off cycling (Figure 21). The aeration system can increase the Dissolved Oxygen concentrations throughout the water column by about 2 mg/l within a two-week period. The larger 75 HP blower is not more efficient than the 40 HP blower. The Association will continue operational testing in 2010.

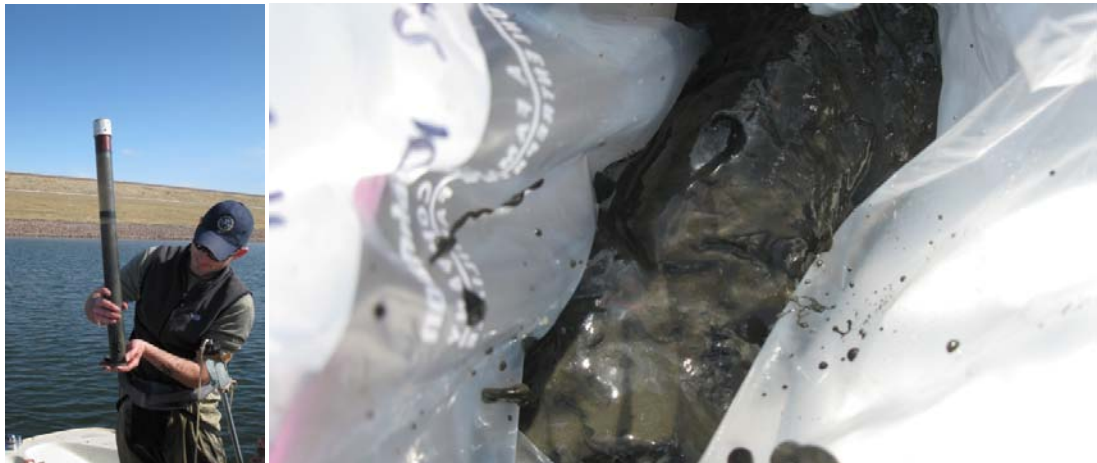
Figure 22 Jamie Anthony (CDOW) Helped Core Sediments Bear Creek Reservoir

The total suspended sediment load in the reservoir has been generally constant over the historic monitoring period with periodic storm events dumping large volumes of sediment into the reservoir. The Association in 2009 noted no significant change in reservoir depth. Bottom sediments remain a mixture of fine sand, silt and mud. At reservoir monitoring site 40, bottom surface sediments as observed in 2009 were predominately a fine-grained black mud Figure 22.

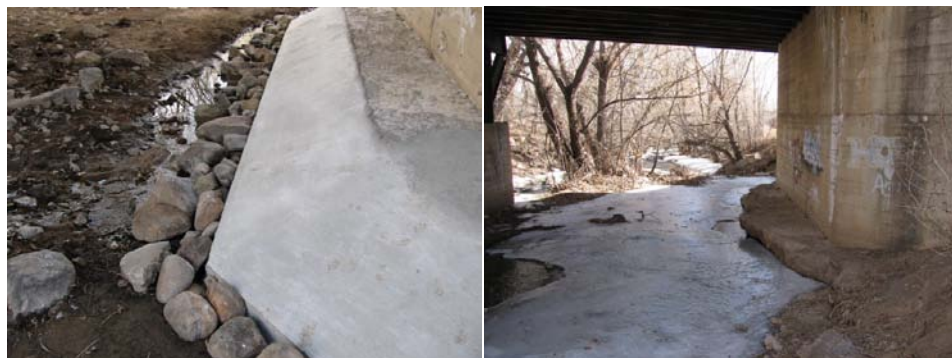
Figure 29 Runoff Controls Added To Bridge Repairs

The Association works with Jefferson and Clear Creek Counties to identify erosion problem areas. The Association recommends use of best management practices to reduce potential erosion problems. The Jefferson County Road and Bridge Department while fixing bridge damage added rock runoff controls to prevent erosion near the bridge structure (Figure 29).

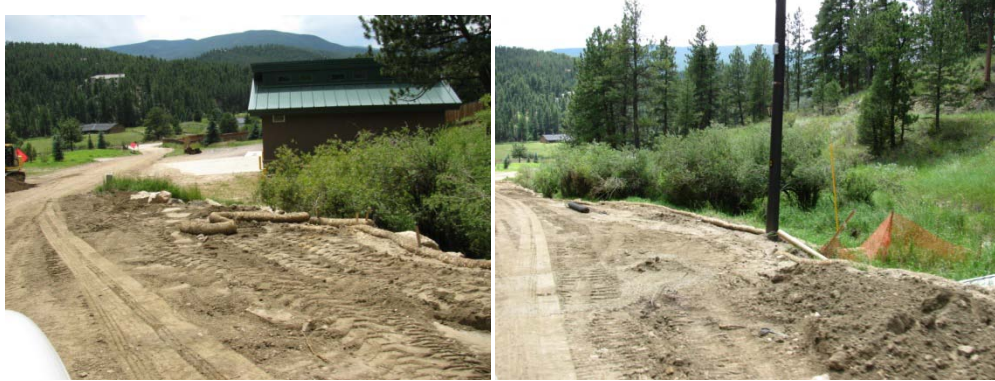
Figure 30 Potential Erosion and Drainage Control Problem in Clear Creek County

In Clear Creek County, a construction project has flagged for having a potential erosion management problem (Figure 30).
