Technical Memorandum BCWA

Re: BCWA TM 2018.07 Barr Milton TMDL Summary

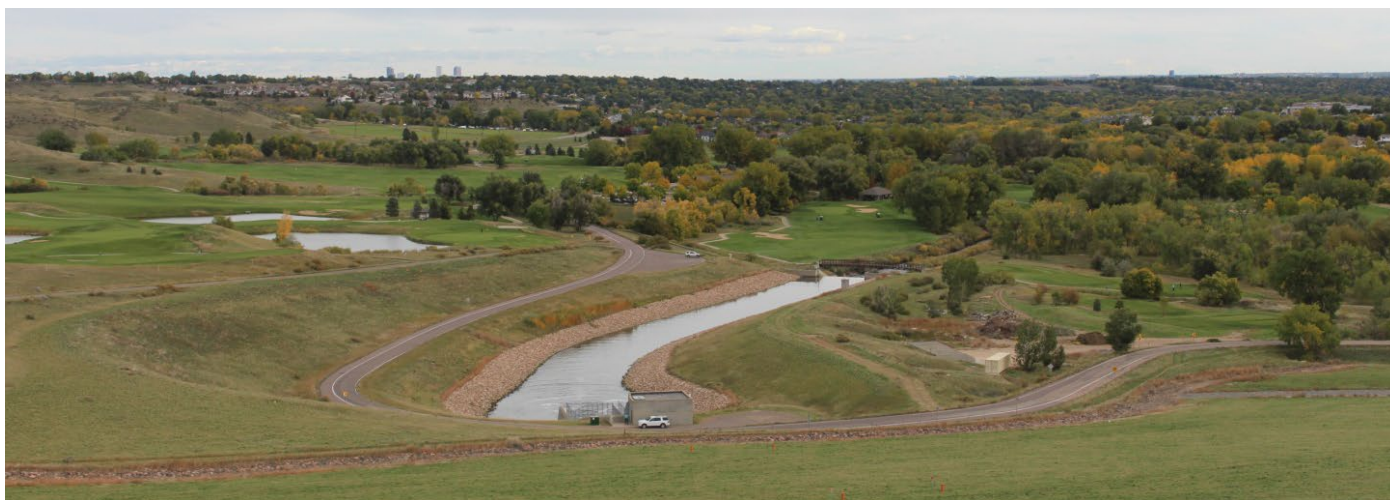
Figure 1 BCWA Site 45 is located below the Weir in the Outfall Trace

The Bear Creek Watershed is in the defined “data” shed for the BMW pH/DO TMDL. The Bear Creek Watershed boundary is defined in *BCWA Policy 13 Watershed Boundary*. Discharge from Bear Creek Reservoir is identified as a “point” source and input to the BMW pH/DO TMDL and model. As such, the BCWA site 45 is identified as a source that contributes about 1.8 % of the external load of Total Phosphorus (See Table 1). The BMW pH/DO TMDL defines the contribution of Total Phosphorus from Bear Creek for both Barr Lake and Milton Reservoir at 1,167 kg/year or 2,672.7 pounds/year. The Association uses site 45 data to estimate Bear Creek Reservoir mass-balance loading and discharge.

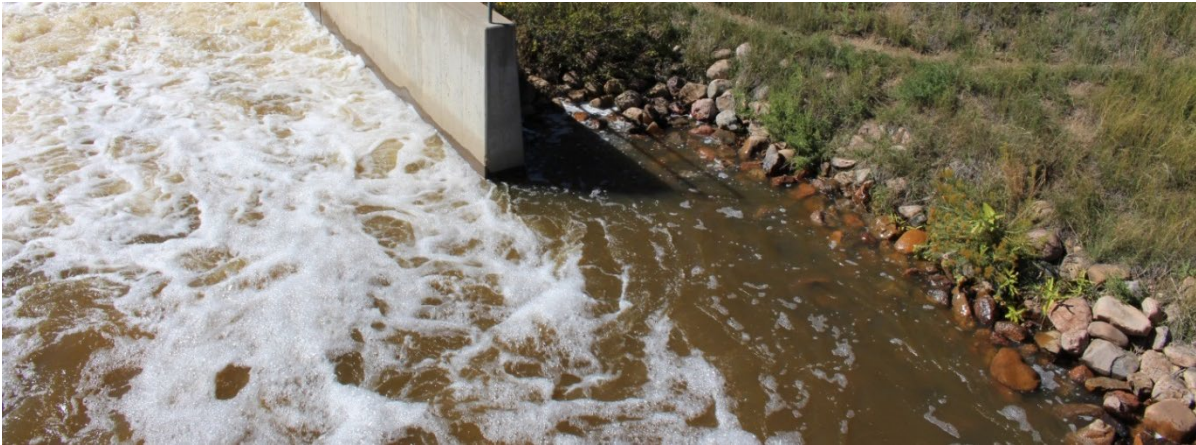
Figure 2 BCWA Site 45 Sampling Location below Weir.

The average inflow into Bear Creek Reservoir from both Turkey Creek & Bear Creek (1987-2018) was 30,123 acre-feet per year. The highest flow was in 2015 with 118,925 acre-feet flowed through the reservoir. In 2018, 6,293 acre-feet flowed from the reservoir. There is a state DNR staff gage above the weir at site 45, which allows the Association to monitor flow at the monitoring station.

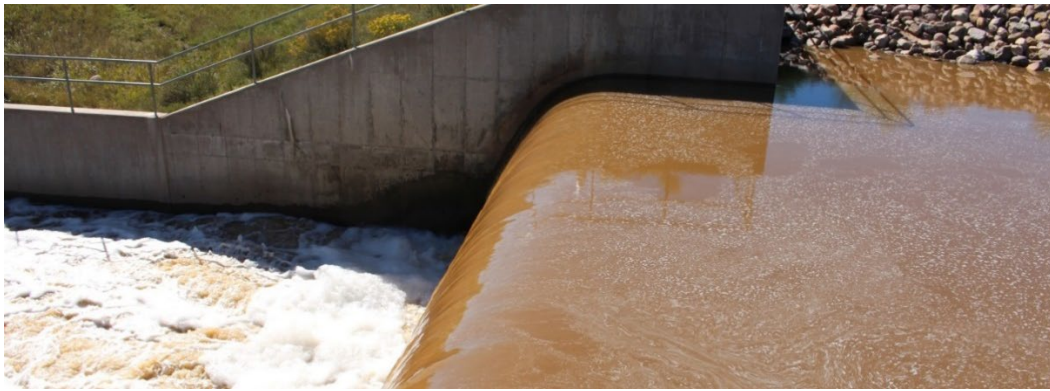
Figure 3 Sediment and Nutrient Load Typically Associated with Spring Flows

In the period from 2000 through 2018, the average Total Phosphorus at BCWA site 45 was 2,801 pound/year (Table 2). Problematic years are 2007, 2013, 2015 and 2016. In 2007, the flow predictions were used for the downstream Sheridan gage (Table 2 and Figure 3). Although the Association believes the actual flow at site 45 was less than measured at Sheridan, the total load would still exceed the target of 2,672.7 pound/year.

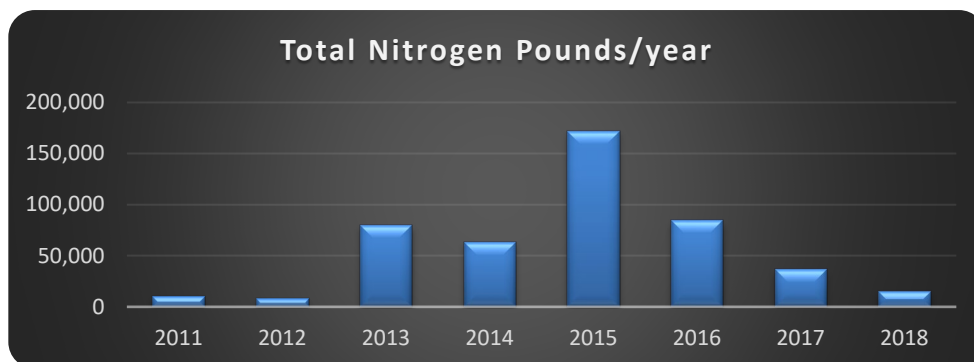
Figure 6 Total Nitrogen Trend

Since nitrogen is an issue, the Association estimated the nitrate loading at BCWA site 45 from 2000-2016 and Total Nitrogen from (2011-2018). In 2018 the average Total Nitrogen concentration discharged from the reservoir as measured at BCWA site 45 was 692 ug/l. This equates to about 15,538 pounds/year. Figure 6 and Table 2 shows the Total Nitrogen loading at BCWA site 45.

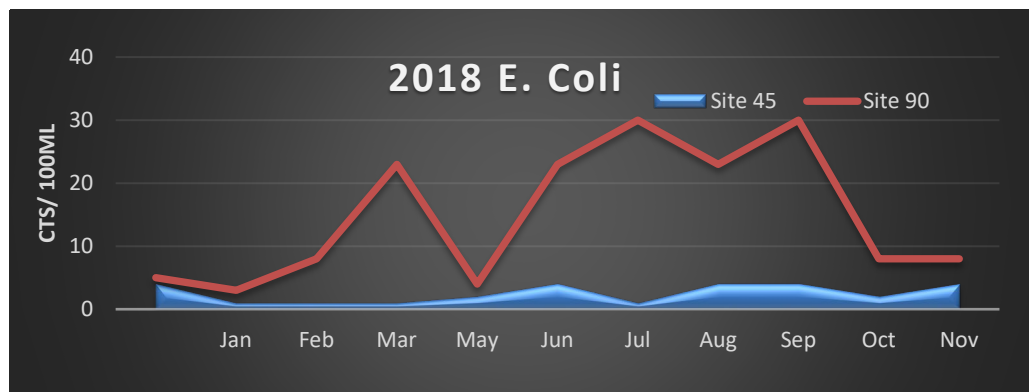
Figure 7 E.coli at Site 45 vs. Site 90 at Wadsworth

Table 4 shows the E. coli geometric mean data at BCWA site 45 from 2004-2018. Figure 7 compares E. coli data at BCWA site 45 with the downstream Wadsworth BCWA site 90. There is no E. coli problem associated with discharge from Bear Creek Reservoir.
