# Technical Memorandum BCWA

**Date:** February 8, 2018  
**To:** Bear Creek Watershed Association  
**From:** Russell N. Clayshulte, Manager  
**Re:** BCWA TM 2018.02 UBCW Summary

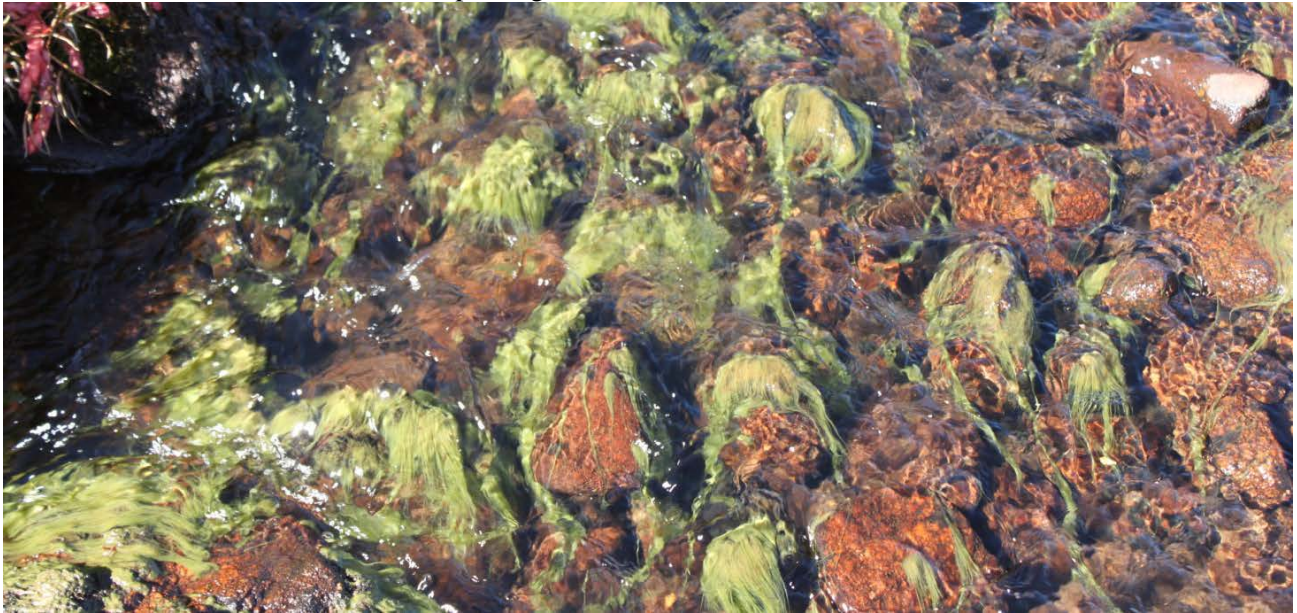
**Figure 2 Excessive periphyton growth on hard substrate in Bear Creek**

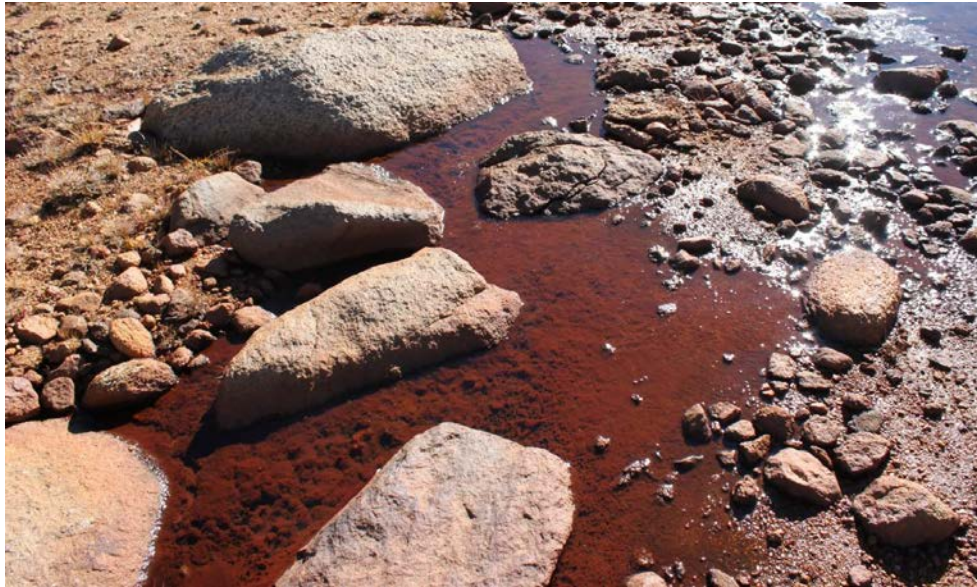
**Figure 3 Excessive red algal growth typical in fen ponds along the suspected pollutant plume flow**

The preliminary data analyses from just visually tracing high algal productivity in the fen ponds showed extremely elevated nutrients, that were higher than found anywhere else in the watershed (Figure 3). In 2013, measurements from only a single estimated emergent point of the plume had a seasonal average total phosphorus of 1,801 ug/l (maximum 4,112 ug/l), with a conservative estimate of 129 pounds/month discharged into upper Bear Creek (potentially over 400 pounds in the warm season). That is potentially more total phosphorus discharged into Bear Creek than 10 out of 16 wastewater treatment plants discharge in an entire year. Denver Parks and Recreation in 2013 repaired the new vaults and the 2014 water quality data suggests this helped resolve part of the nutrient loading.

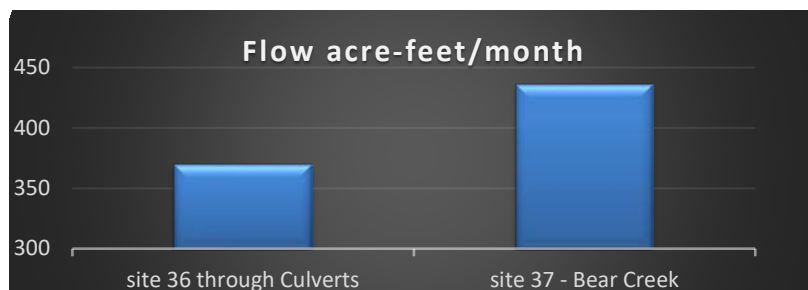
**Figure 4 Monthly estimated flows**

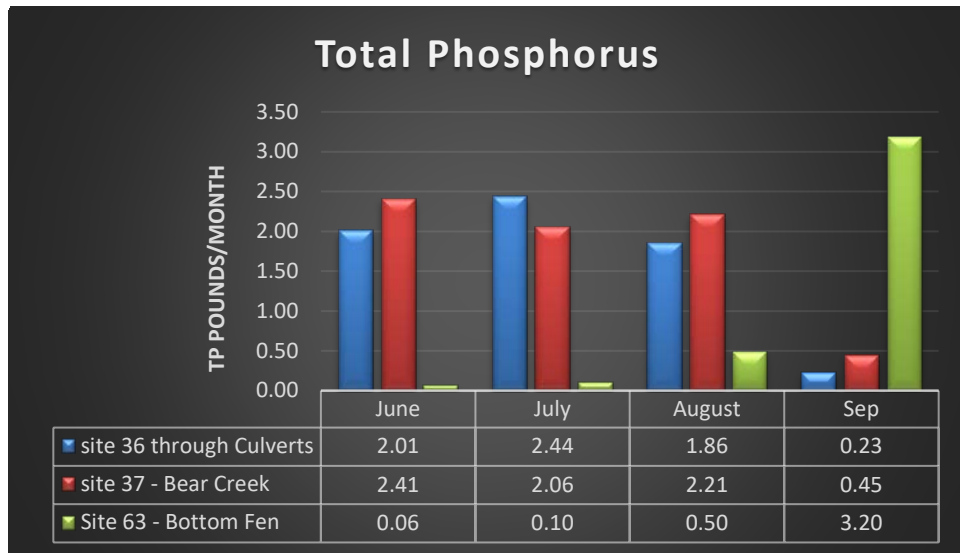
Figure 5 Total Phosphorus Loading

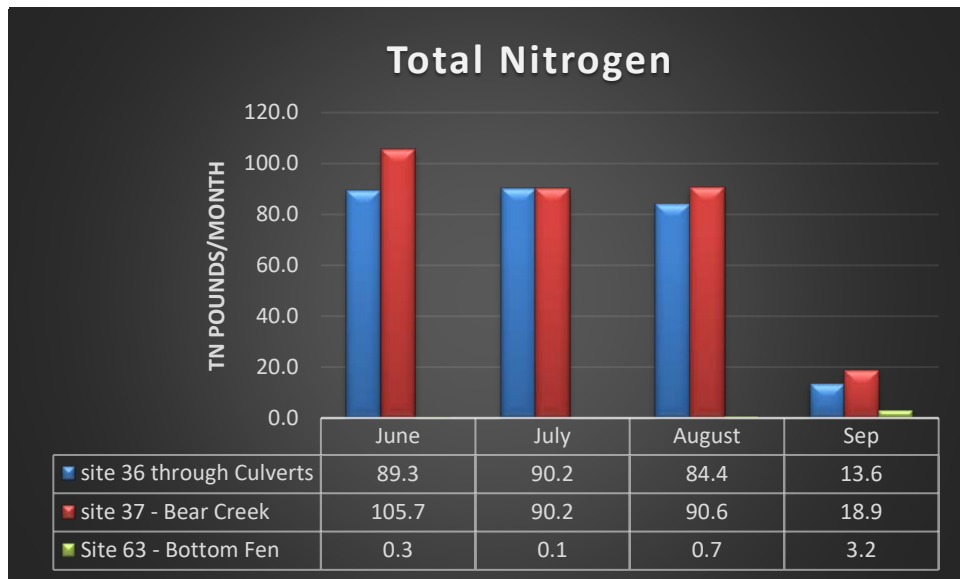
Figure 6 Total Nitrogen Loading

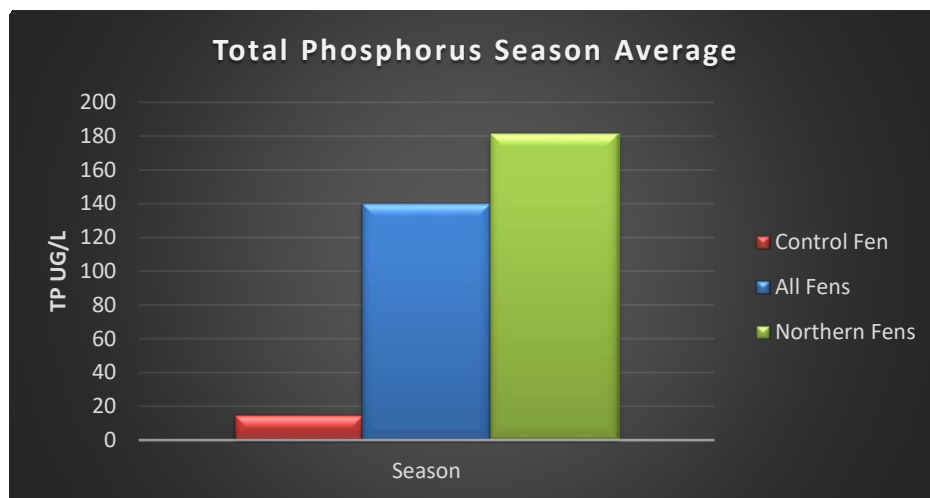
**Figure 8 Seasonal Average Phosphorus in Fen Ponds**

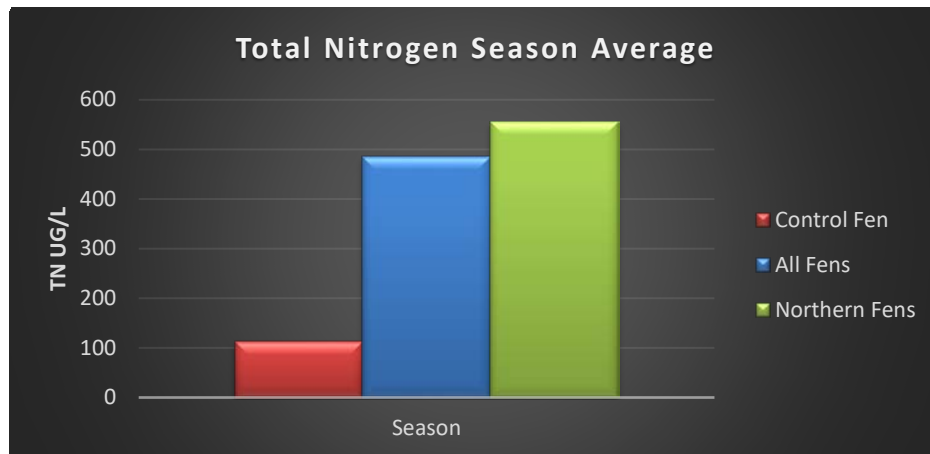
**Figure 9 Seasonal Average Total Nitrogen in Fen Ponds**
